300 Tdi engines

A modification to simplify timing belt inspection

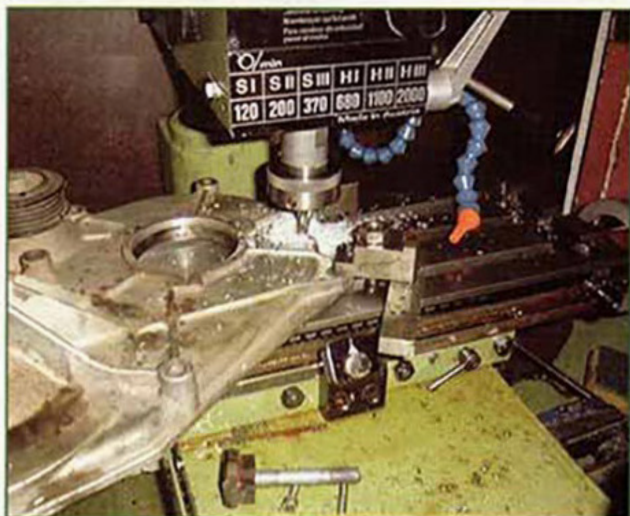
Milling a 10 mm slot into the timing case

My solution was to modify the timing cover castings before refitting them. I milled a 10 mm slot into the case periphery, and added a closely fitting steel plug attached to an adjacent bolt head. The modification is, I think, pretty clear from the pictures taken in my workshop.
