300 Tdi engines

A modification to simplify timing belt inspection

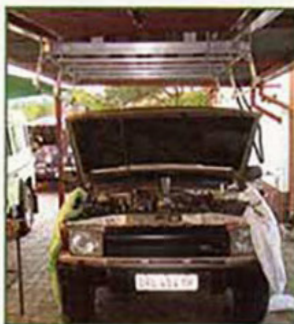
My solution was to modify the timing cover castings before refitting them. I milled a 10 mm slot into the case periphery, and added a closely fitting steel plug attached to an adjacent bolt head. The modification is, I think, pretty clear from the pictures taken in my workshop.

Home Workshop indeed!
